Research article

Restoration of continuous casting machine mold copper plates made of Cr–Zr bronze using multi-pass friction stir lap welding

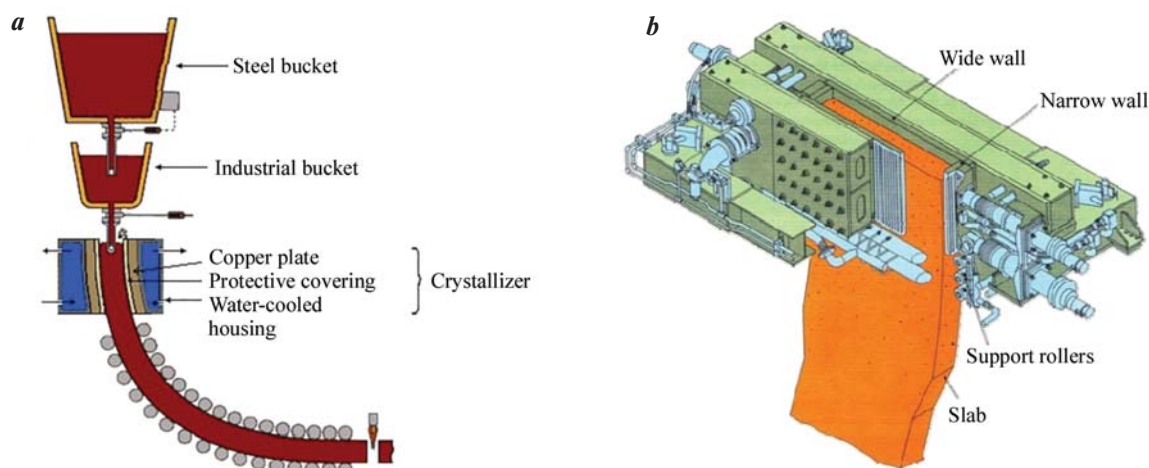
Fig. 1. Schematic view of the slab continuous casting machine (CCM) (*a*) and mold design for the slab CCM (*b*)

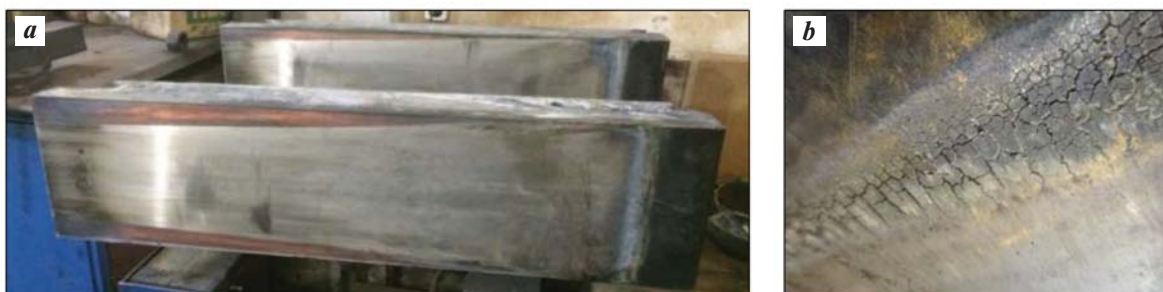
Fig. 2. Electroplated coatings defects: wear (*a*) and heat cracks (*b*)

Nevertheless, the imported galvanic coatings employed as protective coatings present significant drawbacks: notable susceptibility to wear and tear (Fig. 2, *a*), the occurrence of thermal cracks within the coating (Fig. 2, *b*), alongside high costs and limited environmental friendliness associated with the galvanization method.

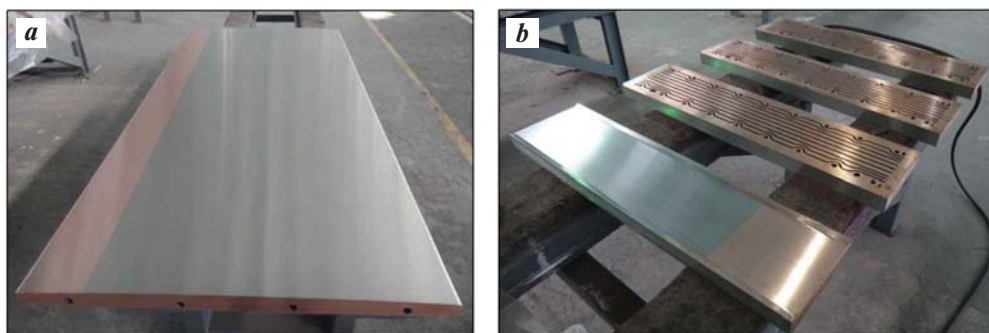
Fig. 3. Slab CCM mold plates: wide (a) and narrow (b)

of Metal Physics, Institute of Engineering Science of Ural Branch of the Russian Academy of Sciences, Ural Federal University, and several metallurgical enterprises has successfully developed and implemented an innovative technology for the restorative repair and production of new copper plates for CCM molds, integrating wear-resistant composite coatings [1; 3] (Fig. 3).

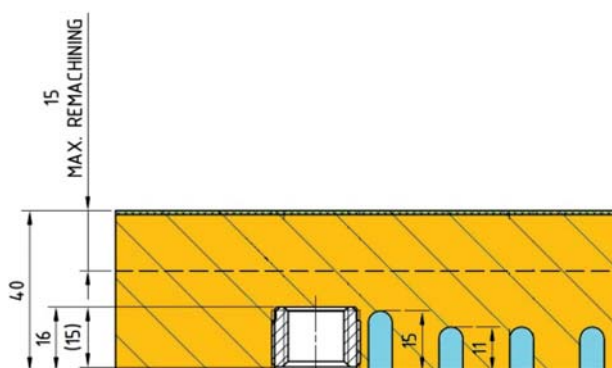
Fig. 4. Schematic diagram of the copper CCM mold plate
Dimensions in mm

The pressing challenge of restoring copper plates in molds after reaching the minimum allowable thickness remains unresolved. When the loss of copper plate material reach 10–15 mm due to wear and repair cycles (Fig. 4), the costly plate with cooling channels is typically discarded as it no longer meets the necessary mechan-

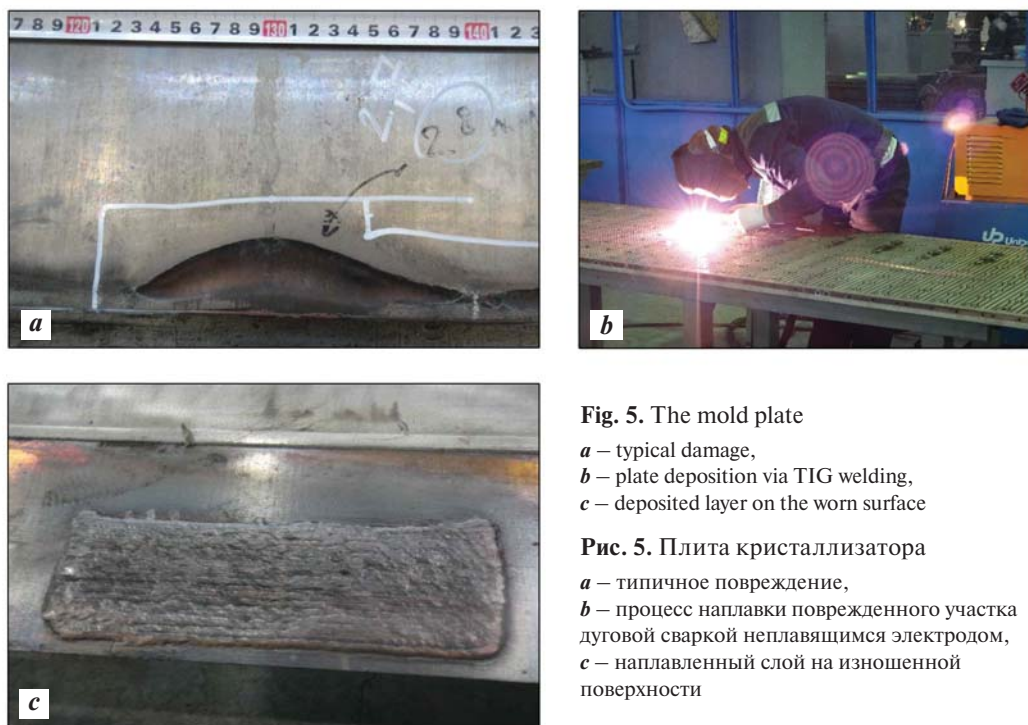
Fig. 5. The mold plate

a – typical damage,
b – plate deposition via TIG welding,
c – deposited layer on the worn surface

Presently, the restoration of copper plates of continuous casting molds primarily relies on arc welding using a non-consumable electrode within inert gases (Fig. 5). However, this process exhibits low manufacturability concerning this specific product due to the metallurgical intricacies involved in welding this material. Copper and its alloys possess distinctive attributes such as high thermal conductivity, heat capacity, coefficient of thermal expansion, and a susceptibility to forming hot cracks and pores. Notably, within the temperature range of $t = 250 \div 550$ °C, copper experiences a reduction in strength and ductility [10]. These properties necessitate the preheating of a solid plate during TIG welding, within a fairly narrow temperature range of approximately 350 ± 10 °C. Throughout the TIG welding process on a solid plate, maintaining the temperature within this narrow range proves challenging. This difficulty significantly escalates the labor intensity compared to volume-based metal deposition estimations. The constant

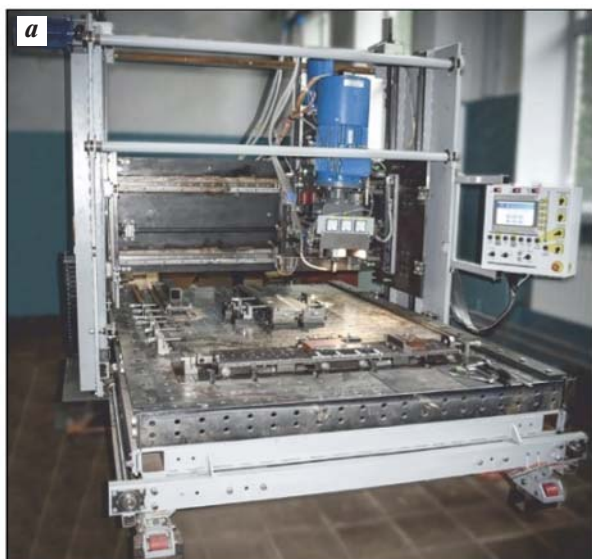
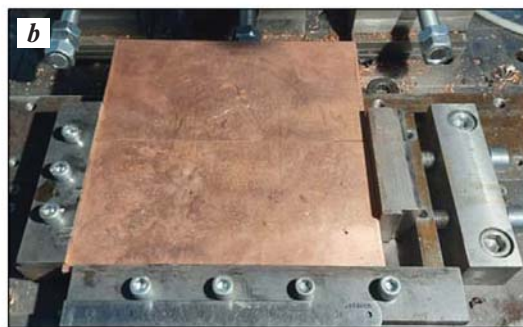
Fig. 6. FSW machine: general view (*a*) and equipment for securing restorable plate and filler material on the welding table (*b*)

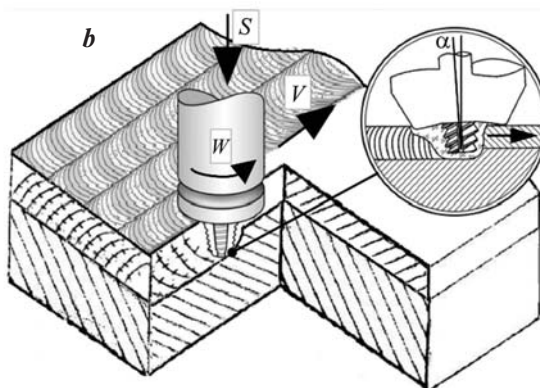
Fig. 7. Heat-resistant stir tool (*a*) and schematic drawing of multi-pass FSLW (*b*)

S – load, W – tool rotational speed, V – longitudinal welding velocity, α – tilt angle

Multi-pass lap welding was executed through a sequence of successive passes, with a seam axis step of 6 mm, which accounts for 0.86 of the average diameter of the tool's conical pin, measuring 7 mm. The welding parameters were as follows: load $S = 13.7\text{--}15.7$ kN, spindle

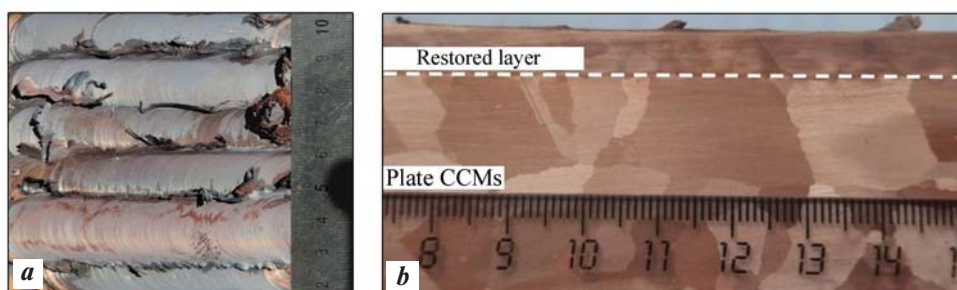
Fig. 8. Appearance of the FSW restored layer (*a*) and macrostructure of the restored layer and substrate in a transverse cross-section (*b*)

rostructure of the welded joint on a transverse section (across the passages) revealed specific characteristics (Fig. 8, *b*): the structure of the used bronze plate exhibited large recrystallized grains, measuring between 5 to 20 mm.

In Figure 8, *b*, it is evident that multi-pass welding, with a 6 mm step, generates a continuous bronze layer approximately 5 mm thick on the plate's surface. This layer is formed due to the partial overlap of welded joints. The restored layer exhibits a relatively uniform macrostructure. Importantly, no observable continuity defects such as breaks, cracks, or pores were detected either across the entire cross-section of the welded joint or along the boundary of the connection between the applied material and the metal of the plate undergoing restoration.

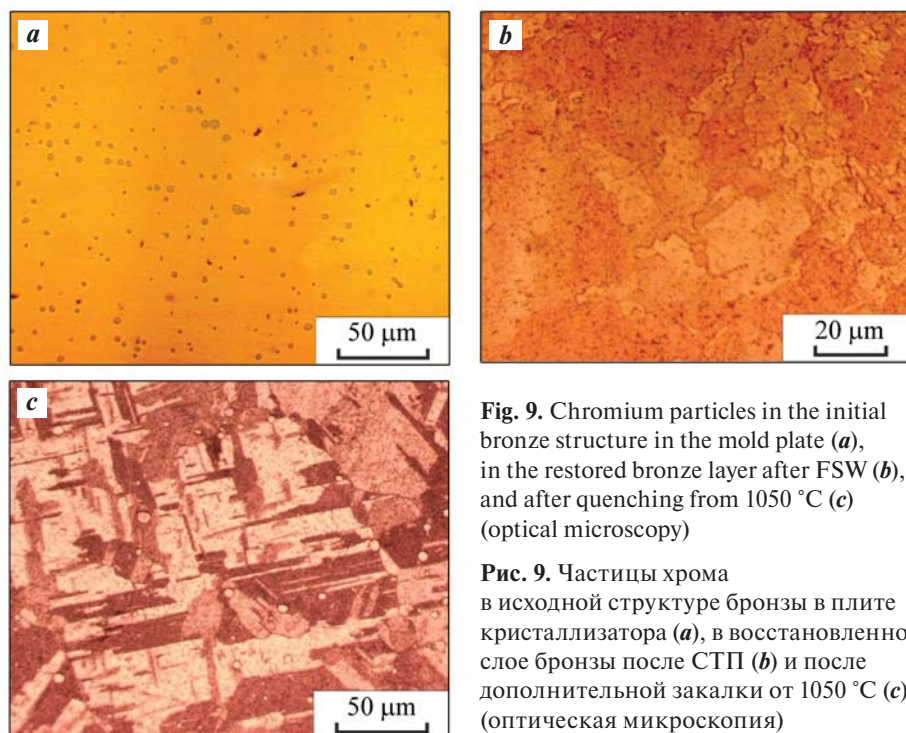
Fig. 9. Chromium particles in the initial bronze structure in the mold plate (*a*), in the restored bronze layer after FSW (*b*), and after quenching from 1050°C (*c*) (optical microscopy)

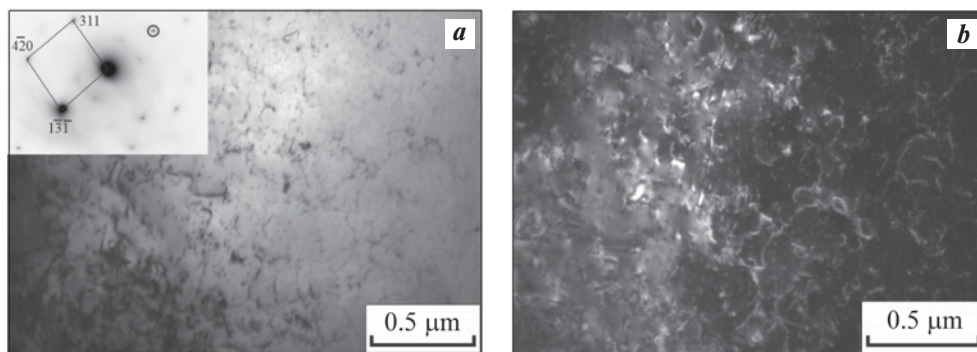
Fig. 10. Initial microstructure of the Cr–Zr bronze (TEM)

a – bright-field image and electron-diffraction pattern, zone axis $[125]$; *b* – dark-field image in the $\bar{1}31_{\text{Cu}}$ reflection

Transmission electron microscopy observations revealed the existence of a specific quantity of dislocations within the copper grains (Fig. 10). However, the elevated hardness of the restored CCM mold plate, measuring between 116–126 HV1 (Fig. 11 and 12, curve *I*), is primarily attributed not only to these structural characteristics but predominantly to the presence of pre-deposits in the aged bronze, specifically Guinier–Preston zones, and nanodispersed chromium particles that are coherent with the matrix. These elements generate elastic stress fields within the matrix [44–46].

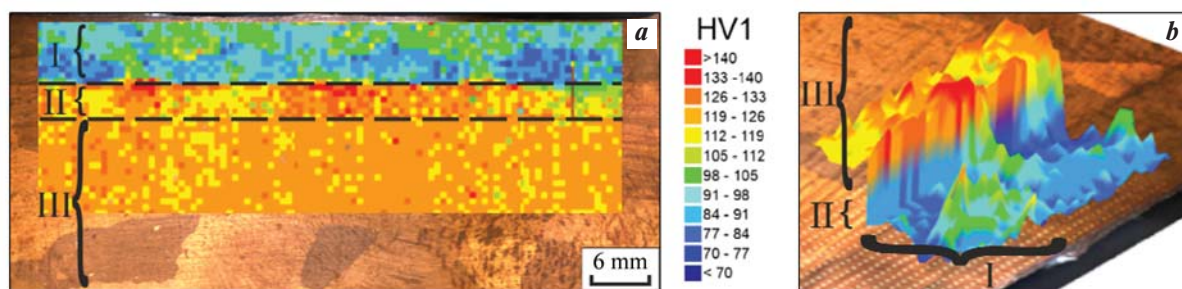
Fig. 11. Hardness distribution of the weld: 2D-map (*a*) and 3D profile (*b*)

I – stir zone of the restored layer; *II* – thermomechanically affected zone; *III* – initial (base) metal of the mold plate

differences or noticeable drops in hardness were observed in the overlap area of adjacent passages. Within the thermomechanically affected zone (refer to Fig. 11, zone *II*), a slight increase in hardness was noted compared to the hardness level in the original (base) metal of the mold plate. This elevated hardness can be attributed to the deformation hardening of the plate material nearby the rotating welding tool caused by its mechanical action.

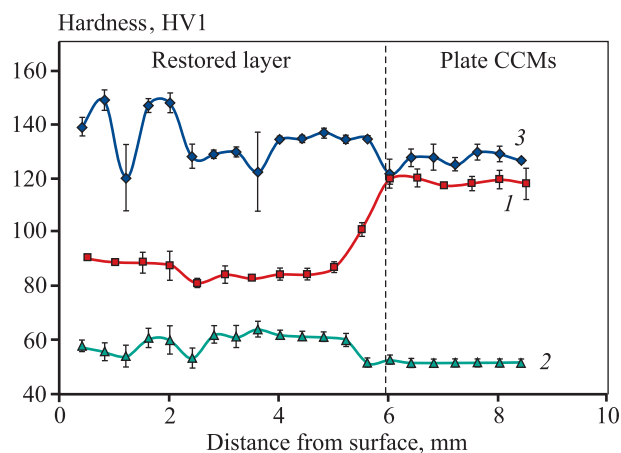
Fig. 12. Hardness distribution in the restored layer and the mold plate after various technological operations

1 – FSW; 2 – FSW + quenching 1050°C;
3 – FSW + quenching 1050°C + aging at 450°C

The substantial decrease in hardness within the stir zone, from the initial 116–126 HV1 of the continuous caster mold plate to the range of 85–105 HV1 (as observed in Fig. 11 and 12), despite the significant refinement of the bronze grain structure (as depicted in Fig. 8, *b* and 14), is attributed to recrystallization and overaging processes resulting from multi-pass FSW. During the FSW of chromium zirconium bronze, the temperature measured at the periphery of the tool shoulder, composed of the heat-resistant alloy, registered at 500–550 °C (Fig. 16) using a non-contact laser pyrome-

the hardness to values between 52–62 HV1, observed in both the restored layer with a dispersed structure and the coarse-grained base material of the plate (Fig. 12, curve 2). Interestingly, even after one hour of hardening at $t = 1050\text{ }^{\circ}\text{C}$, coarse chromium particles up to 5 microns in size, initially present in the bronze structure of the original plate (as seen in Fig. 9, *a*) and post-FSW treatment (as shown in Fig. 9, *b*), retain in the structure (seen in Fig. 9, *c*). This retention is due to the limited solubility of chromium in copper, which at the specified quenching temperature does not exceed 0.6 wt.% [41].

Quenching followed by aging at $t = 450\text{ }^{\circ}\text{C}$ results in the strengthening of the weld joint to 120–150 HV1 (as observed in Fig. 12, curve 3). This strengthening effect occurs despite the presence of large grains within the structure of the restored layer (seen in Fig. 17, *c*, *d*), formed during the heating to $1050\text{ }^{\circ}\text{C}$ for quenching. In the bright-field TEM image, a contrast in the form of arcs is observed within the grain bulk (Fig. 19, *a*), indicating the initial stages of fine strengthening phase formation. Moreover, the dark-field image in Fig. 19, *b* indicates the release of a considerable number of dispersed particles enriched with chromium from a super-saturated solid solution. These released particles play a significant role in efficient dispersion strengthening, affecting both the layer restored by FSW and the origi-

nal plate of chromium-zirconium bronze (as seen in Fig. 12, curve 3). This signifies the dominant role of the dispersion strengthening mechanism over the grain boundary strengthening mechanism. Active release of dispersed chromium particles during aging is facilitated by the presence of chromium-enriched Guinier–Preston zones or chromium particle nuclei, as observed in the discussion regarding Fig. 18, *c*, *d*, subsequent to hardening. Consequently, this heat treatment process (quenching followed by aging) effectively reverses the de-strengthening effect observed in the stir zone of chromium-zirconium bronze, a result of overaging during the multi-pass FSW caused by overheating.

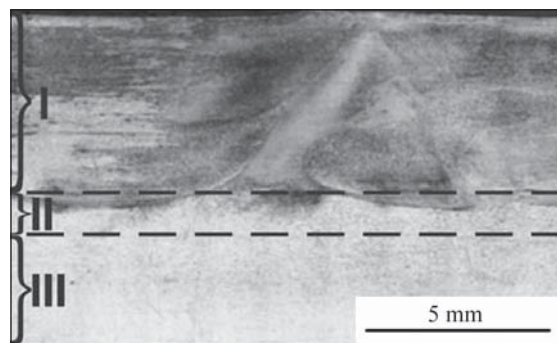
Fig. 13. General view of a transverse section of the weld

I – stir zone of the restored layer; II – thermomechanically affected zone; III – initial (base) metal of the mold plate

Optical metallography analysis reveals a notable dispersion in the structure of the deposited bronze layer, particularly evident in the weld nugget (Fig. 13). This dispersion results in the weld structure exhibiting grain sizes, ranging from units to tens of micrometers (Fig. 14). In the upper section of the layer restored by FSW (stir zone) (as shown in Fig. 13), a fine-grained equiaxial recrystallized structure emerges, characterized by a grain size of approximately 5 μm (refer to Fig. 14, *a*). While the predominant size of recrystallized grains in the stir zone falls within the range of

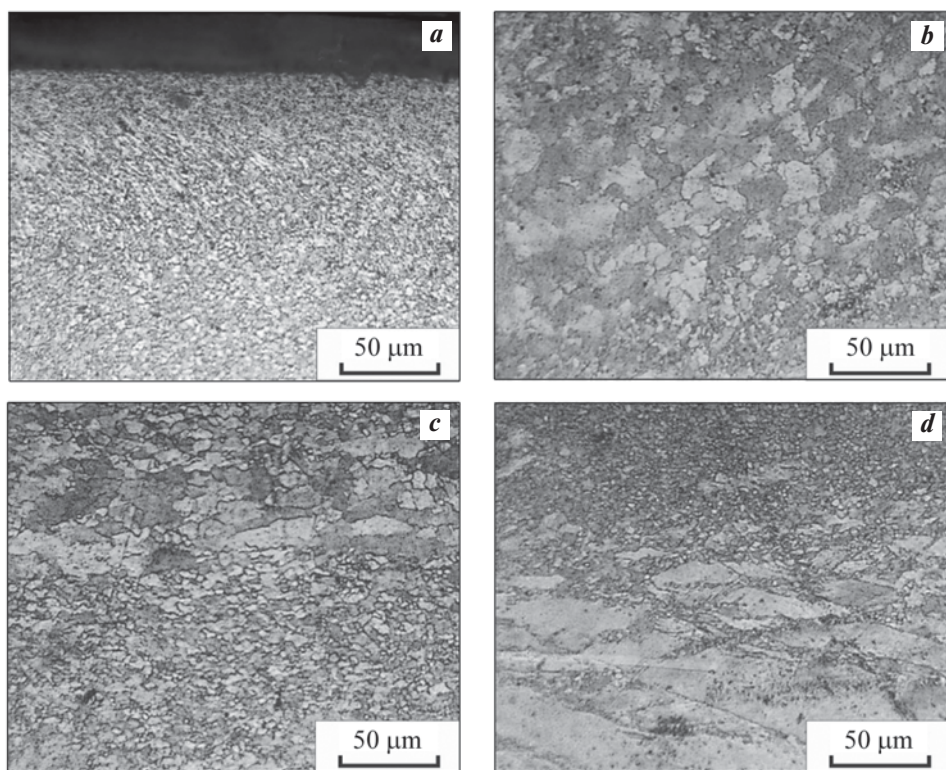
Fig. 14. Structure of chromium-zirconium bronze in the restored layer of the continuous caster mold plate after FSW (optical microscopy)

a – near the surface; *b* – mid area, *c* – area of variable grain structure, *d* – the transition zone «layer – base metal»

5 to 15 μm , observations at different depths beneath the surface reveal areas and bands spanning several hundred micrometers with a grain size of up to 20–50 μm (see Fig. 14, *b, c*). Within the thermomechanically affected zone (refer to Fig. 13), a combination of fine-grained structure and deformed coarse grains is evident (depicted in Fig. 14, *d*). These areas gradually transition into the structure resembling the initial material of the mold plate.

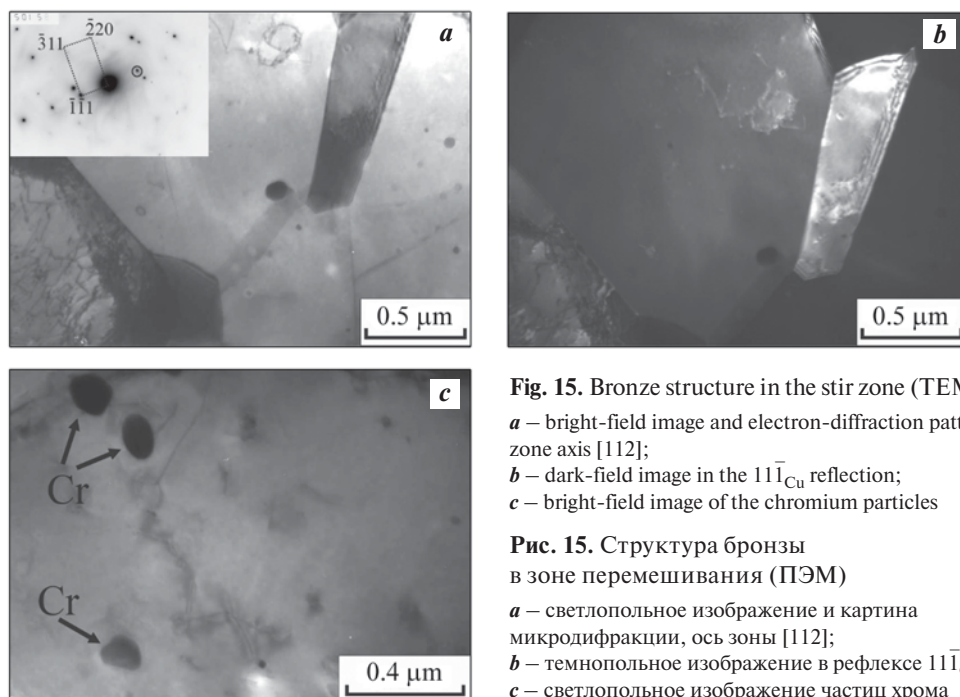
Fig. 15. Bronze structure in the stir zone (TEM)

a – bright-field image and electron-diffraction pattern, zone axis [112];
b – dark-field image in the $11\bar{1}_{\text{Cu}}$ reflection;
c – bright-field image of the chromium particles

Transmission electron microscopy examinations in the stir zone reveal the presence of areas with deformed grains alongside a significant number of clean recrystallized grains characterized by broad banded boundaries (Fig. 15 *a, b*). Within these grains, chromium particles are observed (Fig. 15, *c*), with sizes that can extend up to 100 nm. Heating to high temperatures and intense plastic deformation during multi-pass FSW leads to the initiation of dynamic recrystallization processes behind the welding tool and contribute to the enlargement of strengthening phases (overaging). It's previously shown (refer to Fig. 9, *b*) that FSW does not result in complete dissolution of coarse chromium particles, which are initially present in the structure of the original plate (as seen in Fig. 9, *a*). Consequently, these relatively larger chromium particles, which can reach sizes of up to 5 μm , do not exert a decisive influence on the material's hardness.

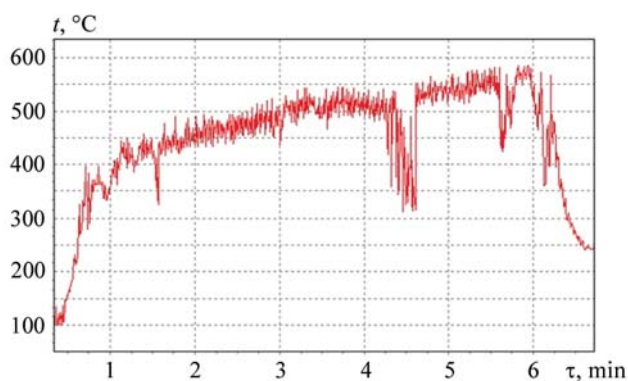
Fig. 16. Temperature variation at the periphery of the welding tool shoulder during FSW of Cr–Zr bronze

ter. Simulation results [40] indicate that the temperature within the weld zone (stir zone) surpasses the measured value by 100–150 °C, reaching 600–700 °C. Additionally, the accumulation of metal heating under multi-pass FSW conditions contributes to the softening effect. In a study [39], during a single-pass FSW with a tool made of H13 die steel, which heated the welding zone to approximately 420 °C, a reduction in bronze softening was observed. Conversely, this led to material strengthening by 1.5–2.0 times. This outcome suggests that less heating did not trigger the development of overaging processes.

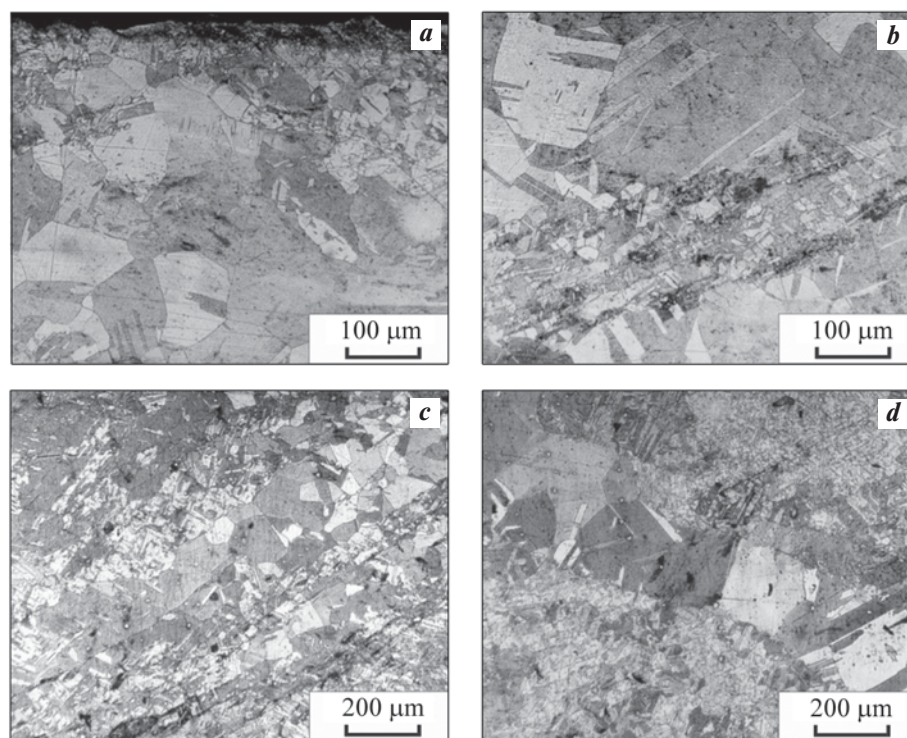
Fig. 17. Cr–Zr bronze structure in the restored layer after various heat treatments (optical microscopy)

a, b – FSW + quenching from 1050 °C; *c, d* – FSW + quenching from 1050 °C + aging at 450 °C
a, c – near the surface; *b, d* – in the mid area of the restored layer

Quenching the material from 1050 °C induces substantial growth in many grains within the layer restored by multi-pass FSLW (Fig. 17, *a, b*). This growth occurs due to the development of recrystallization processes during high-temperature exposure to the quenching process. The thermal dissolution of dispersed strengthening phases, particularly chromium particles measuring up to 100 nm observed post-welding (refer to Fig. 15, *c*), facilitates the growth of recrystallized grains. Consequently, in certain areas of the restored layer,

grain growth expands to several hundred microns, often accompanied by the formation of annealing twins (depicted in Fig. 17, *a, b*). The observed grain coarsening and the dissolution of dispersed reinforcing chromium particles contribute to significant softening, reducing

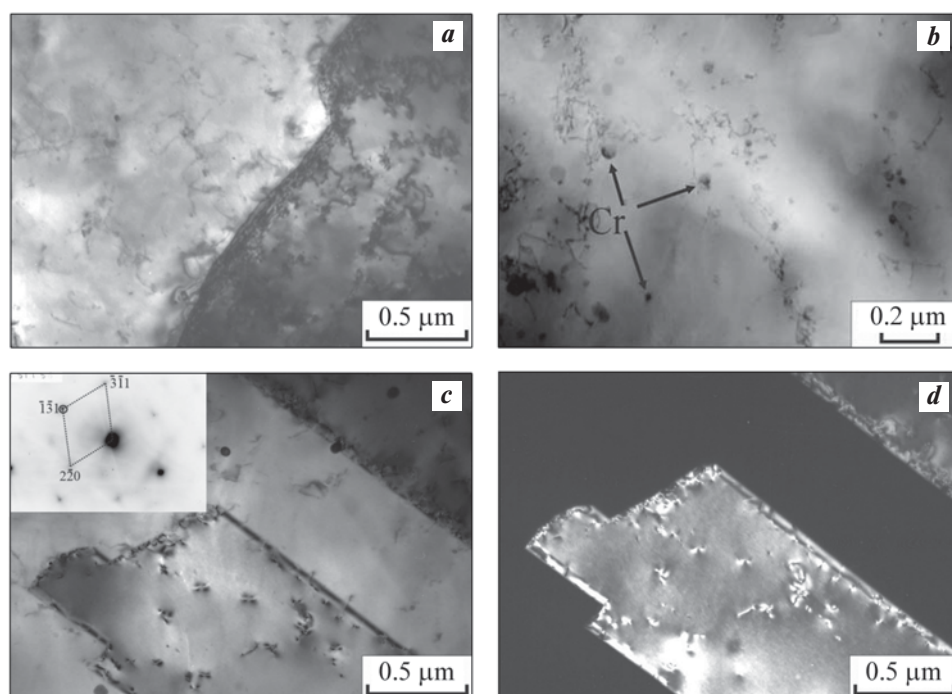
Fig. 18. Bronze structure in the stir zone of FSW joint at a depth of 1 mm (*a*, *b*) and at a depth of 4 mm (*c*, *d*) after quenching from $1050\text{ }^{\circ}\text{C}$ (TEM)

a, *b* – bright-field images; *c* – bright-field image and electron-diffraction pattern, zone axis $[114]$; *d* – dark-field image in the $\bar{1}\bar{3}1_{\text{Cu}}$ reflection

According to the observations made through transmission electron microscopy, following the quenching process, coarse grains exhibit a limited number of dislocations found both inside the grain and at high-angle boundaries (Fig. 18, *a*). Additionally, undissolved dispersed chromium particles, measuring up to 30 nm, are present (Fig. 18, *b*), alongside twins (Fig. 18, *c*, *d*). Figures 18, *c*, *d* also show a deformation contrast in the form of “butterfly wings” or arcs. The structural images reveal specific contrasts, such as “coffee beans” and “rings”, which indicate the presence of Guinier–Preston zones within the structure. These zones are known

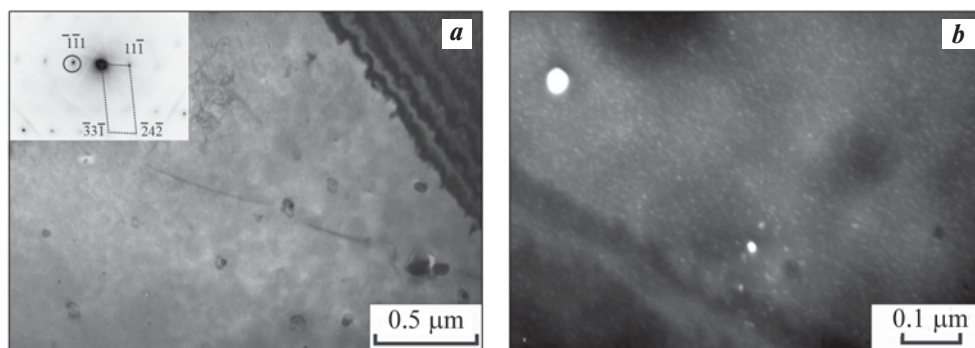
Fig. 19. Bronze structure in the stir zone near the surface at a depth of 1 mm, after quenching from 1050 °C followed by aging at 450 °C (TEM)

a – bright-field image and microdiffraction pattern, zone axis [123]; *b* – dark-field image in the $\bar{1}11_{\text{Cu,Cr}}$ mixed reflection
